Normal MR Appearance of Laparoscopic Nissen Fundoplication

J. E. Huprich¹, J. L. Fidler¹, C. Deschamps², D. Stanley³

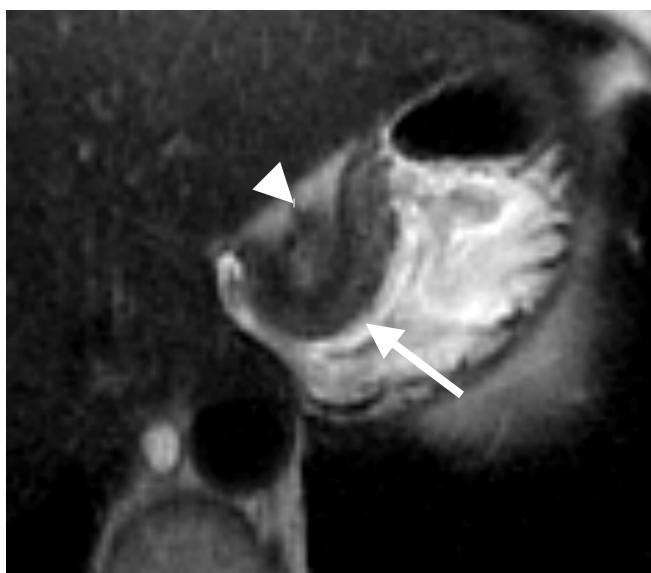
Figure 1. Axial view demonstrates esophagus (arrowhead) partially surrounded by fundoplication (arrow)

Results: None of the seven patients had evidence of hiatal hernia or stomach above the wrap. One patient had a supradiaphragmatic location of the wrap. The wrap had a similar appearance in all seven patients (Figure 1 and 2)

Conclusion: An intact Nissen fundoplication has a typical appearance on MR. The centrally located esophagus incompletely surrounded by the two-layers of gastric fundus resembles a "hot dog in a bun". Demonstration of this finding along with an infradiaphragmatic location of the wrap and absence of stomach or hiatal hernia above the wrap is consistent with a positive surgical outcome. Our findings show that MR can be performed in a rapid fashion and provides exquisite anatomic information regarding the location and integrity of the wrap. Further studies assessing the accuracy in diagnosing complications seems warranted.

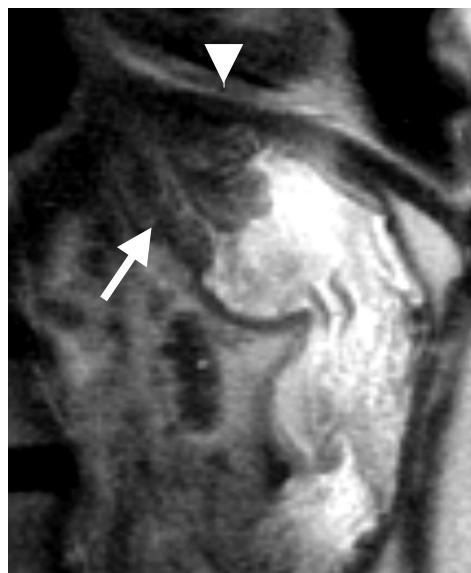
Figure 2. Coronal view demonstrates wrap located below diaphragm (arrowhead) and no hiatal hernia or stomach seen above wrap (arrow)
