# MR HYDROGRAPHY IN THE DIAGNOSIS OF PERITONEAL LEAKS IN CONTINUOUS AMBULATORY PERITONEAL DIALYSIS

**OBJECTIVE:** The purpose of this study was to demonstrate the utility of magnetic resonance (MR) hydrography to diagnose and localize abdominal wall leaks among continuous ambulatory peritoneal dialysis (CAPD) patients, using the dialysis solution as a contrast material.

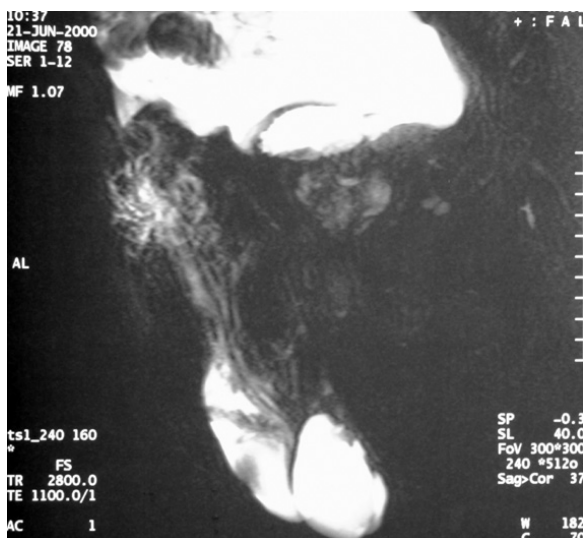
Fig. 1.- MR Hydrography in a CAPD patient showing a left leak inguinal hernia
