# Current Challenges for Creating a Wireless MR-Compatible Intracranial Pressure Monitor

S. Oh<sup>1</sup>, U. Kawoos<sup>2</sup>, M-R. Toffighi<sup>3</sup>, A. Rosen<sup>2</sup>, and C. M. Collins<sup>1</sup>

<sup>1</sup>Radiology, The Pennsylvania State University, Hershey, Pennsylvania, United States, <sup>2</sup>School of Biomedical Engineering, Drexel University, Philadelphia, Pennsylvania, United States, <sup>3</sup>Electrical Engineering, The Pennsylvania State University, Middletown, Pennsylvania, United States

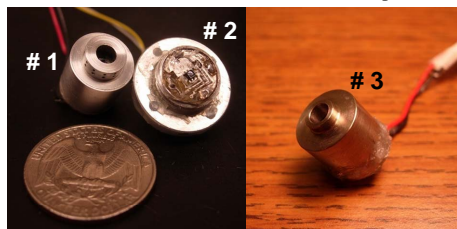
Figure 1. ICP devices. The casing material of device #1, #2, and #3 were stainless-steel, aluminum, and titanium, respectively.

**Method:** Three different designs of the ICP device [3], as shown in Figure 1, were tested. First, the devices were tested to see how strongly they experienced force and torque in the MR environment. The casings of the devices were stainless steel, aluminum, and titanium for devices #1, #2, and #3, respectively. Second, general gradient-echo (GRE) and spin-echo (SE) images were acquired to observe how the device distorts the magnetic field due to magnetic susceptibility ( $\chi_m/10^{-6}\text{cm}^3/\text{mol}$ ). A conductive agar-gel phantom (agar 7g/liter, NaCl 170mM, CuSO<sub>4</sub> 6.3mM) was prepared for temperature measurements as well as GRE and SE scanning, as shown in Figure 2(a). Each device was placed in the agar-gel phantom as depicted in Figure 2(b). Finally, temperature changes near the probe were monitored with thermo-optic probes while RF pulses with a time average power of 16.65W were delivered to the coil over a period of 2 minutes [5].
