Imaging of Cartilage Repair

Carl S. Winalski, MD

*Imaging Institute
Department of Biomedical Engineering
Cleveland Clinic*

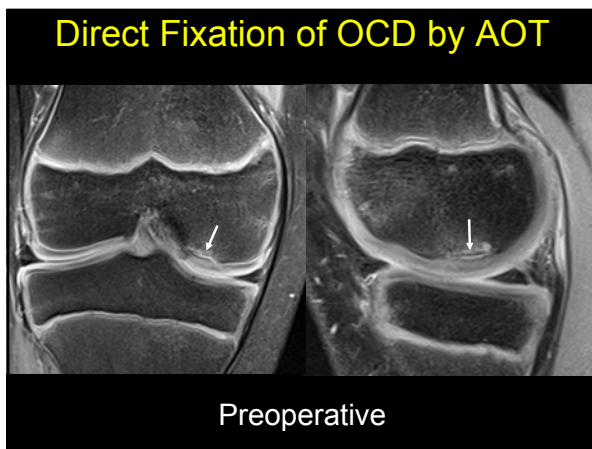
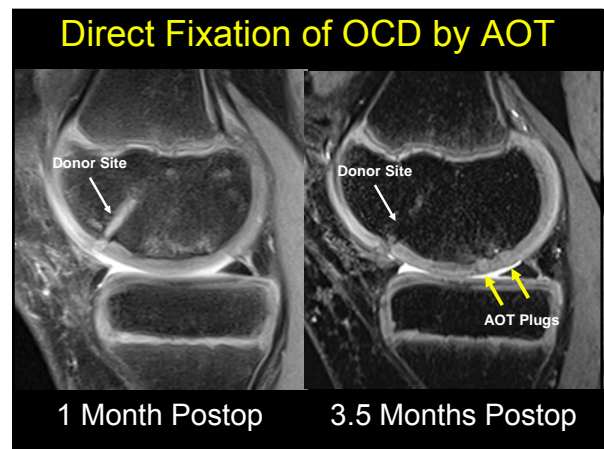
Direct Fixation of OCD by AOT

- Osteochondral lesion fixed in place by osteochondral plugs
- No cartilage defects from pins or screws
- No screw removal needed

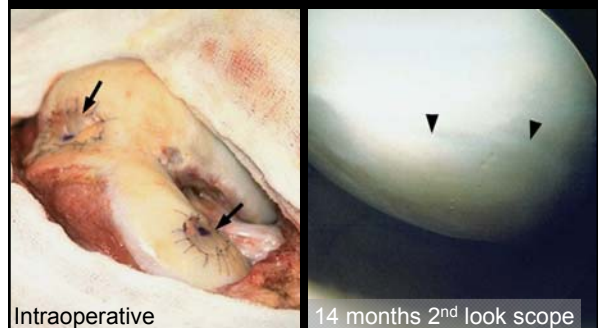
33 y.o. male ACI's of MFC, Trochlea, & Patella

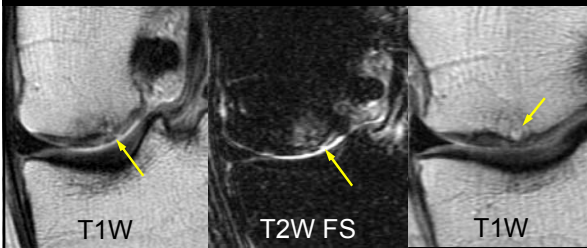
3 yrs. After Abrasion

Irregular contour, advancement of subchondral bone plate at base of lesion

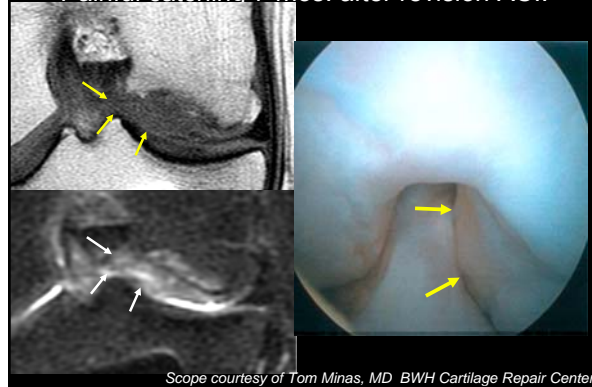
ACI: Periosteal Hypertrophy

Painful catching 7 mos. after revision ACI:

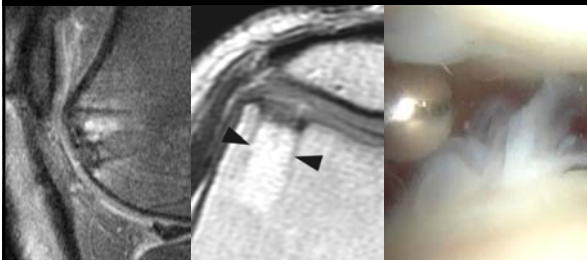
AOT – Knee to Talus

9 months Post-op: hypertrophic tissue
Not seen by MR, but marrow edema present

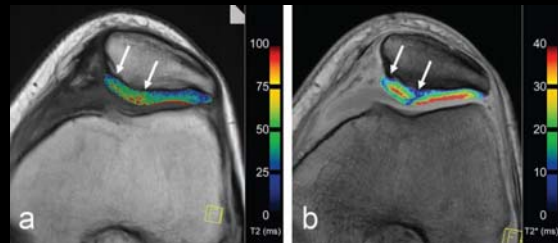
- T2 information may be obtained using spin echo or gradient echo techniques. Arrows mark site of MACI

T2 map – spin echo using 6 echos
flip angle 180°

T2 map – gradient echo using 6 echos
flip angle 20°

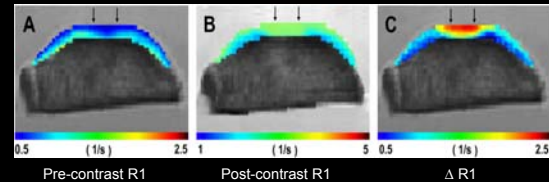
- dGEMRIC correlated with GAG in microfracture repair tissue in goat model.*
- T2 map did not correlate with biochemistry.*

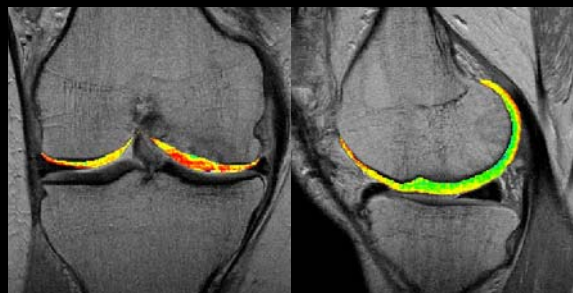
ACI dGEMRIC Measurement of GAG

2 months post-op

1.5 years post-op

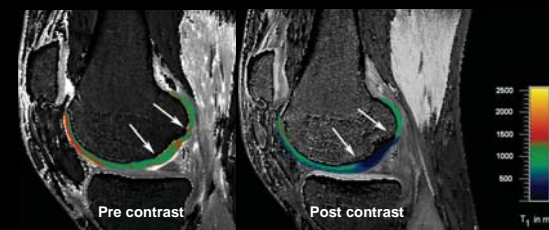
dGEMRIC - Clinical 3D – dual flip angle T1 maps

- dGEMRIC demonstrates lower T1 in the MACI repair (arrows) postcontrast MR following ionic Gd-DTPA indicating GAG content of repair tissue is lower than native cartilage
