Imaging of ACL Reconstruction

Lynne S. Steinbach, M.D.

Department of Radiology and
Biomedical Imaging
University of California San Francisco

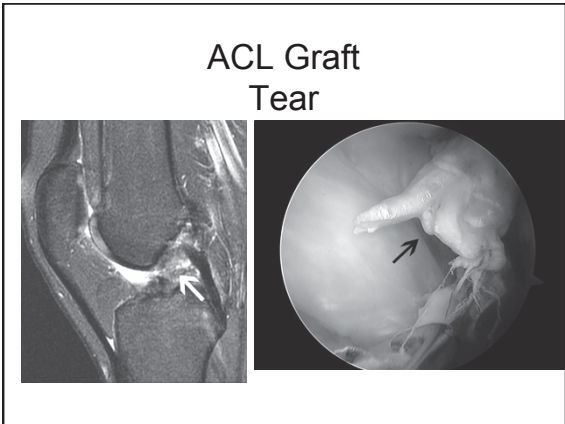
Re-injury: Partial and Full Thickness Tears

- Often a result of recurrent trauma
- Abnormal stress on graft during normal range of motion due to tunnel position

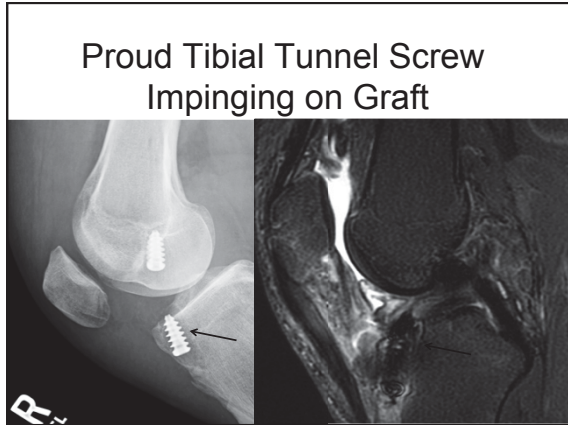
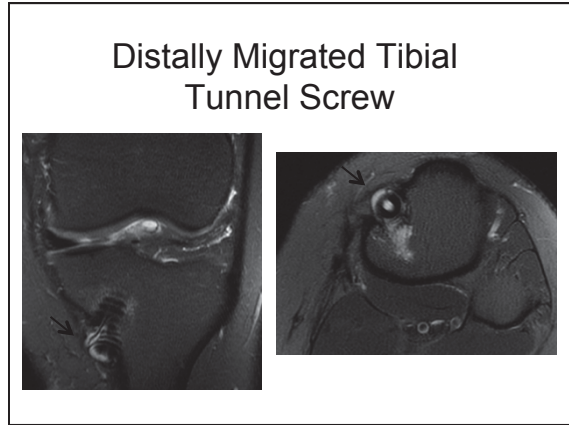
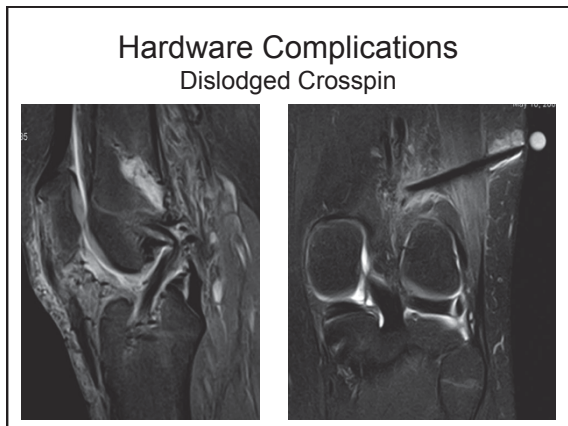
Fractured bioabsorbable crosspin

- Bone graft/screw migration
- Screw impingement on graft
- Pin or screw fracture
 - More common with bioabsorbable screws at time of graft placement
- Dislodged screws
