MRI Compatible Treadmill

E. L. Foster¹, M. Jekic^{1,2}, J. A. Bender^{1,2}, J. W. Arnold³, S. V. Raman^{1,4}, and O. P. Simonetti^{1,5}

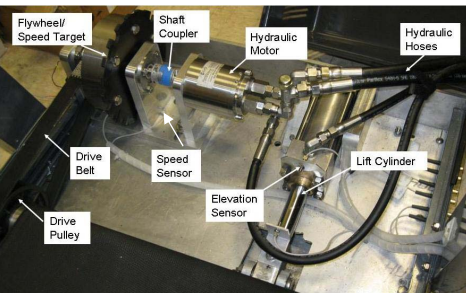
Figure 1: Hydraulic Drive and Elevation Systems

Materials and Methods: All ferromagnetic structural components and fasteners from a commercial rehabilitation treadmill (Landice 8700, Randolph, NJ) were replaced with aluminum and non-ferromagnetic stainless steel equivalents (Figure 1). Hydraulic drive and elevation systems were developed to power the treadmill

using tap water. The running belt was powered by a hydraulic motor, driven by an electric pump located outside the MRI room (Figure 2). A hydraulic cylinder was used to elevate the treadmill (Figure 1). Fiber optic sensors were used for speed and elevation feedback and a Labview (National Instruments, Austin, TX) program used for control. All components were constructed of non-ferromagnetic materials and tested for MR safety using a 0.32T hand magnet (Next Generation Science, Lafayette, IN). The treadmill was placed immediately adjacent to the 1.5T MRI system and connected to the pump via hydraulic hoses routed through a wave guide (Figure 3). MRI

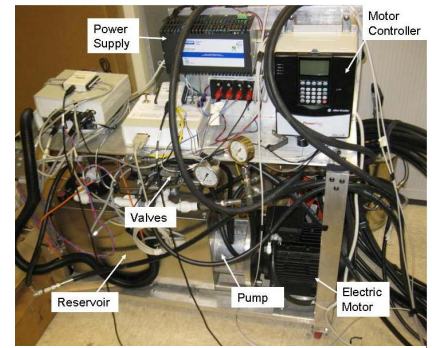
Figure 2: Hydraulic power unit remotely located in MRI equipment room

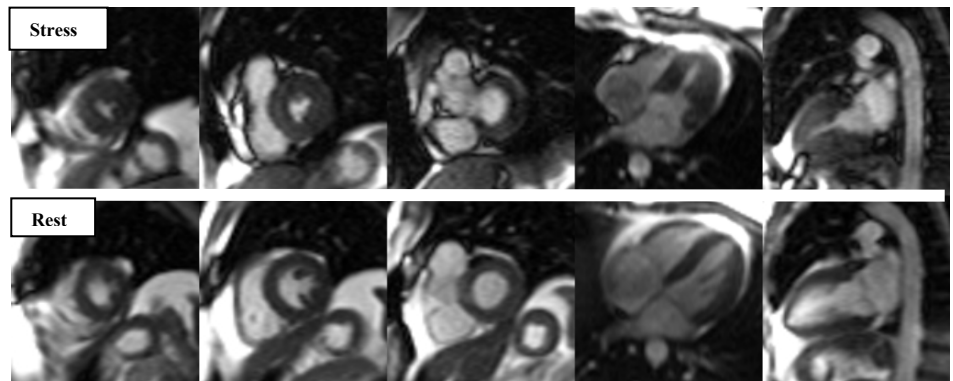
Figure 4: End-systolic cardiac function images obtained at stress and rest

Protocol; each subject achieved target heart rate. The average time to transfer the subject to the MRI table and start imaging was 26.7 ± 6.4 s, and real-time cine imaging covering three short-axis and two long-axis views was completed within 12 s, or an average of 38.7 ± 6.4 s after end of exercise (Figure 4).
