Specialty area: Body MRI Artifacts

Title: Artifacts in Clinical Practice: Causes & Cures

Body MRI Artifacts in Clinical Practice: Causes & Cures

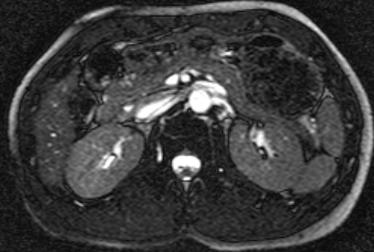
<p>Remove the source of extraneous electrical activity, in this example an acrylic sweater.</p>

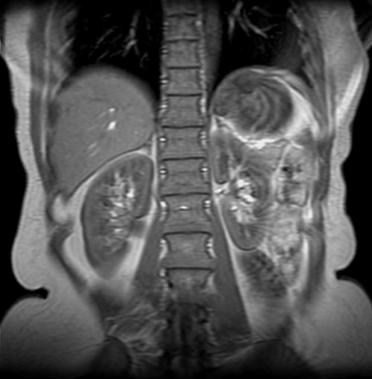
<p>Increasing the receiver bandwidth to 488 Hz/pixel reduces the chemical shift to 0.5 pixels at the cost of a decreased SNR</p>

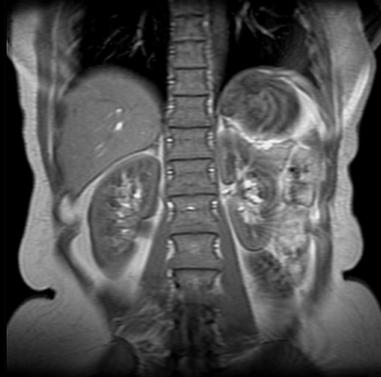
<p>At a TE of 4.6ms water and fat are back in phase and the black border disappears. Note that this in and out-of-phase imaging method may also be used to help characterise fatty lesions.</p>

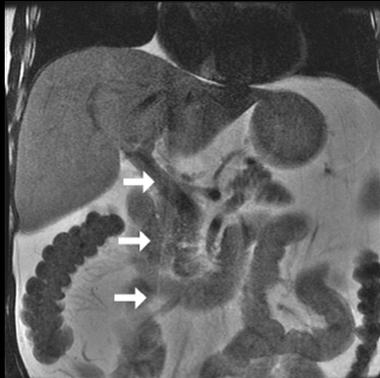
<p>MR acquisition related Parallel imaging artifacts</p>	<p>This artifact is typically seen when the field of view for an image-based parallel imaging technique such as SENSE is used with the field-of-view being too small or the acceleration factor being too high.</p>

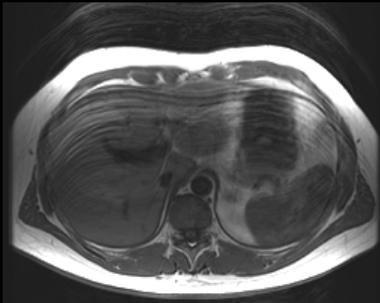
<p>Patient motion related Artifact due to respiratory motion</p>	<p>This artifact is seen as multiple "ghosts" in the phase encode direction due to the modulation of the MR signal as the patient breathes</p>

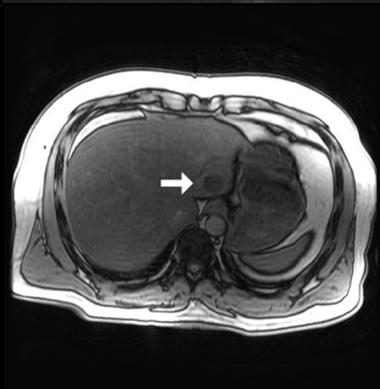
<p>Patient motion related Artifact due to pulsatile flow in the aorta</p>	<p>Pulsatile flow results in a variation in intravascular signal during the acquisition. This variation in the raw MR signal appears as ghosting following Fourier transformation. Here a flow ghost from the aorta appears as a lesion in the liver.</p>

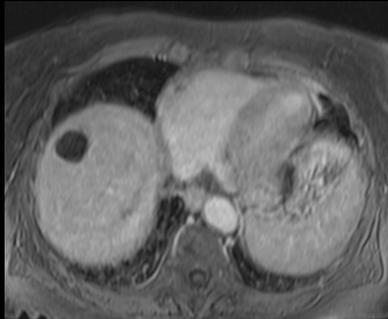
<p>Carefully compare pre and post contrast source images, look for edge artifacts and boundaries, and use motion correction software if possible.</p>

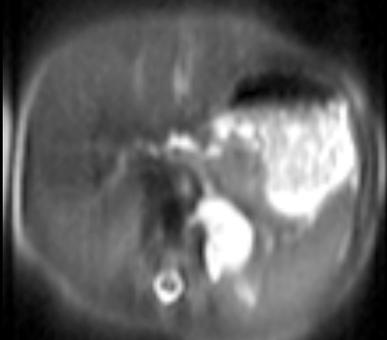
<p>Pulse sequence related Decay of signal during an echo-train readout causes images to appear blurred</p>	<p>Due to the T_2 decay during a fast spin echo readout period the point spread function is broadened resulting in a blurred image.</p>
