The Effects of Breast Radiographic Markers on MRI and MRS: Ex Vivo Testing of Artifacts at High Magnetic Field (4 Tesla)

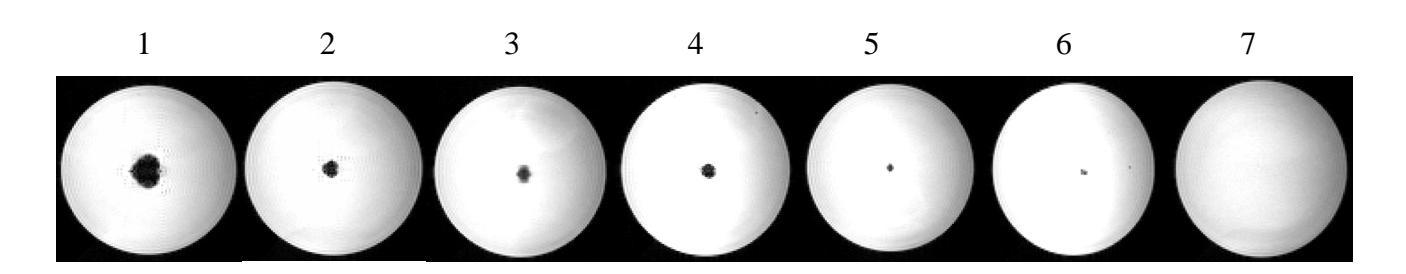
Figure 1: Phantoms representing each radiographic marker

Results: A summary of the imaging and spectral artifacts are shown in Table 1. *Imaging artifact*: All 6 RM clearly produced a void artifact in the gelatin phantoms (figure 1). Imaging artifacts produced by the stainless steel alloy RM varied from 8-18 mm, while the titanium alloy RM showed a 6 mm imaging artifact. The CZO RM showed the least amount of imaging artifact (3 mm). *Spectral Artifact*: All 6 RM created B₀ inhomogeneities which produced spectral distortion. The control voxel had a linewidth of 0.044 ppm. Water linewidths in the stainless steel RM voxels ranged from 0.080-0.567 ppm. The titanium alloy and CZO RM voxel had a linewidth of 0.740 and 0.067 ppm, respectively. The CZO RM showed the least amount of spectral artifact (0.023 ppm).
